Removing Kiln Release Marks

What are kiln release marks?

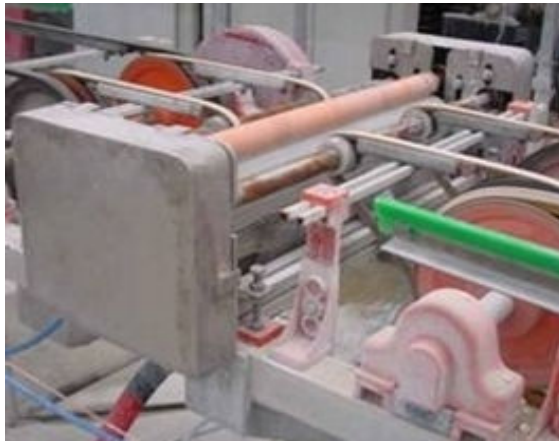
Applying Kiln Release

chemists had to overcome another problem, that of tiles sticking to the ceramic rollers. The solution was to firstly create ceramic rollers with a threshold temperature higher than the kilns, secondly create a pattern on the bottom of each tile that reduced the amount of surface area that contacted the rollers and thirdly create a ceramic coating that could be applied to the back of the tile working as a buffer layer. It is the latter that we are discussing and refer to as a kiln release coating.

The kiln release is comprised of refractory elements and is basically a calcined alumina-silicate engobe (clay slip) with a threshold temperature higher than the kilns. If you look at the back of most ceramic tiles you will see a white material which is the remaining kiln release still left on the tile after firing. In many cases most of the kiln release is removed by the factory. However sometimes there is a reasonable amount of loose residue left on the bottom of the tile and this should be removed before installing as it can interfere with the adhesives ability to bond. In some instances this white residue can also be seen on the top of the tile. This has come from the bottom of the tile that was stacked on top of it in the box. It is this situation that has the potential to create problems.

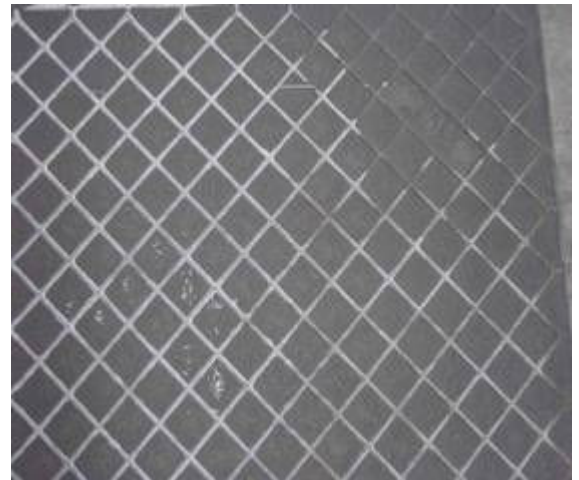
Kiln release easily visible on back of tile

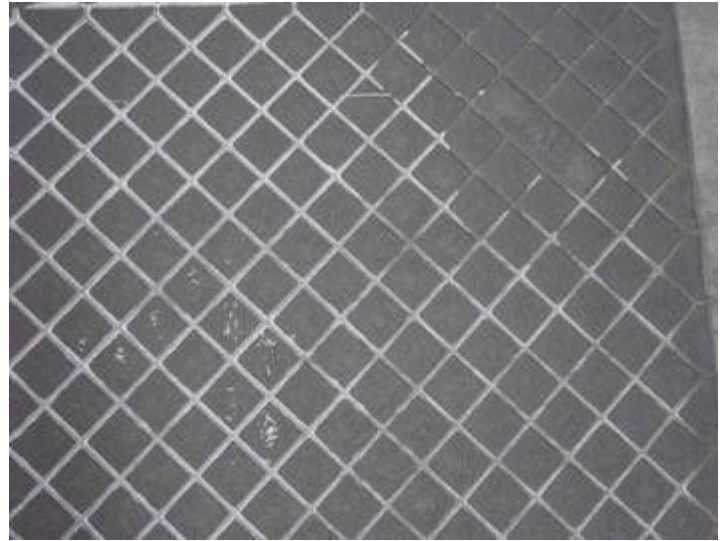
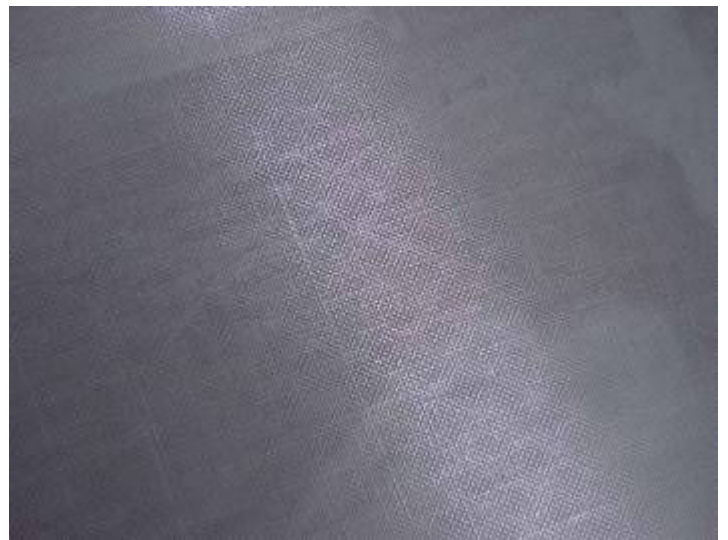
*The kiln release marks in the form of the pressing on the back of the tile are visible in the area highlighted by the light. These were removed using **NanoScrub and Heavy Duty Tile and Grout Cleaner***

However with the advent of Nano-molecular cleaners such as Aqua Mix **NanoScrub** the success of removing these marks has increased immensely.

In our experience using something like **NanoScrub** (an inert abrasive cleaner) alone does not always work. In most instances pre-wetting the marks with an alkaline cleaner such as Aqua Mix

Heavy Duty Tile and Grout Cleaner before using **NanoScrub** achieves the best results. Does this mean we now have a solution for this problem that works in every case? No. It works in about 80% of cases. Where the marks have also been created by additional heat or an engobe with a threshold temperature too close to the tiles they cannot be totally removed. These tiles have to be replaced.
