Is all efflorescence white? (Vanadium & Manganese)

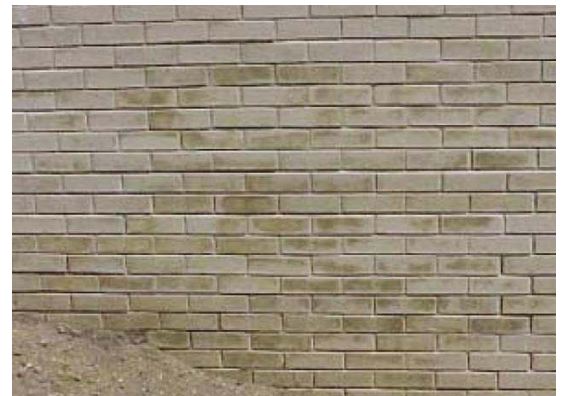
Vanadium on brick

Vanadium appears as either a green or yellowish stain on especially light coloured terracotta and brick. The vanadium salts originate from the clay deposits and are usually vanadyl salts, consisting of sulphates and chlorides or hydrates of these salts.

The correct way to clean vanadium is with caustic materials. The use of cleaners with a base of either sodium hypochlorite or sodium hydroxide will do a good job of removing vanadium salts. Aqua Mix Heavy Duty Tile and Grout Cleaner is a good example of an alkaline cleaner for this task. It is preferable to use them on a dry surface so that the solution can penetrate the tile or brick. Rinsing with clean potable water is recommended after cleaning. It may take several exposures to completely remove the vanadium.

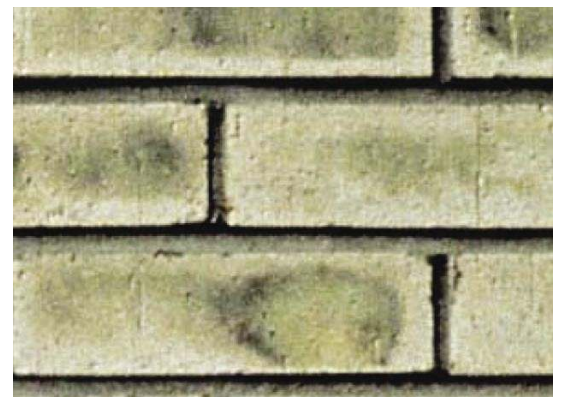
Vanadium sometimes incorrectly identified as mildew or bacteria

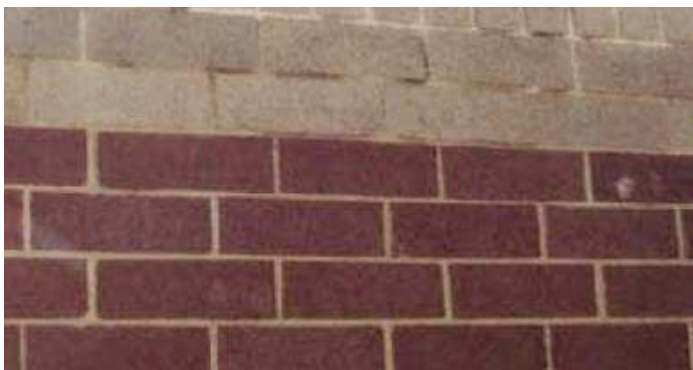
Manganese staining in the grout joint

When a brown, tan or occasionally greyish/brown residue appears on either a grout joint, tile, brick or stone surface it is in most cases manganese efflorescence. Manganese can be naturally occurring as seen in some sandstones as well as man made where manganese is used as an oxide in ceramics to produce brown hues. Unlike vanadium and "common" efflorescence manganese is usually insoluble in water. Therefore to migrate to the surface it firstly needs to be dissolved and this happens primarily when the tile, stone or grout is exposed to an unbuffered acid. The acid can come from an acid wash (something we at Aqua Mix do not recommend as a standard installation practice), from inside the stone (if for example it has other soluble compounds such as iron sulphides that can, when combined with oxygenated water, form sulphuric acid) or in some regions highly acidic rain.

Manganese is further related to vanadium in that it is the sulfate and chloride salts of manganese that migrate to the surface. However unlike vanadium and "common" efflorescence manganese is actually neutralized by the lime in the cement grout joints forming an insoluble compound manganese hydroxide which in turn after thorough drying forms the resulting insoluble stain manganese tetroxide. Removal of manganese unlike vanadium requires an acid, the most effective being oxalic acid. As acid can damage the surface of some tiles and stone and will damage all cementitious grout joints it is advisable to pre-wet the surface before cleaning. A thorough rinse with clean potable water is essential as any remaining acid can not only damage the surface and grout joint but also reactivate dormant manganese.

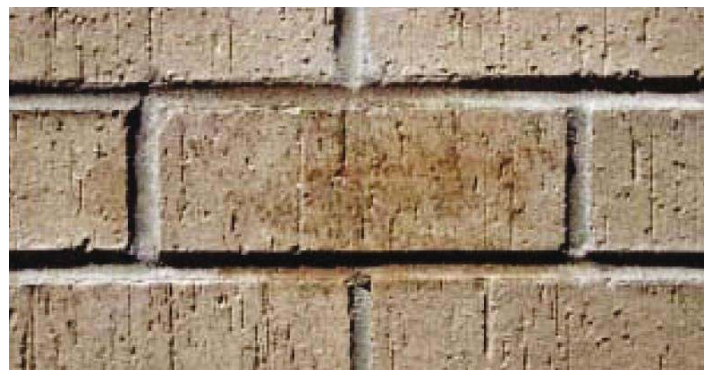
Manganese deposit on brick and grout joint
